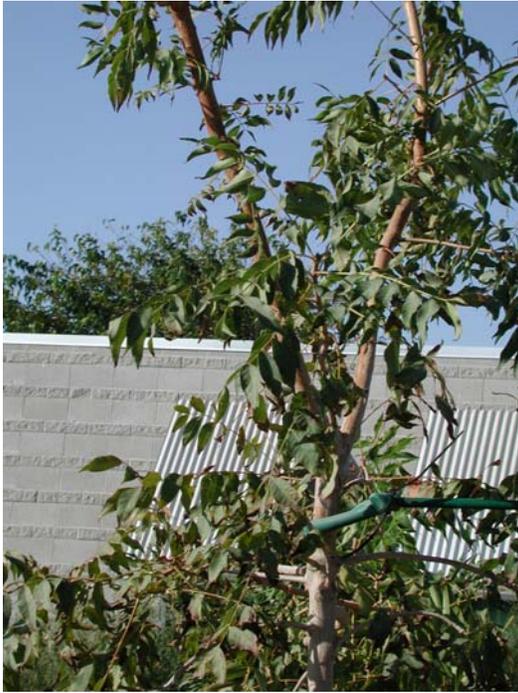
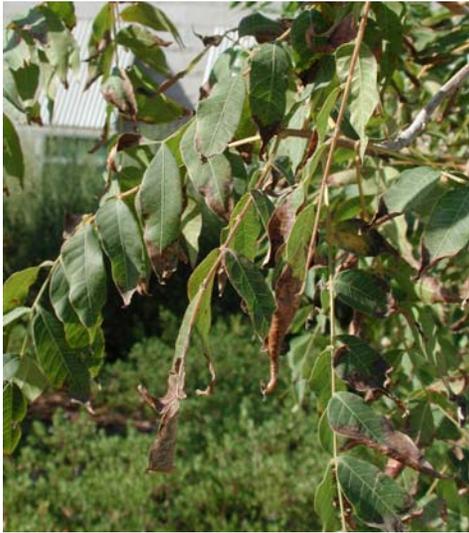
Figure 13. Sprinkler irrigation of salt sensitive landscape plants should be kept below the plant canopy to avoid or reduce wetting of the foliage. Severe damage occurred to the lower leaves of this Chinese Pistache (*Pistacia chinensis*) irrigated with recycled water due to direct contact of salt on the leaves (upper left). Close-up view of lower leaves on Chinese Pistache irrigated with recycled water containing approximately 150 mg L^{-1} sodium and 300 mg L^{-1} chloride. Necrotic areas developed where the recycled water came in direct contact with the leaves (lower left).
