**Elvenia J. Slosson Endowment
Progress Report
2002**

**Measuring the Impact of Site Development on the
Physical and Chemical Properties of Landscape Soils**

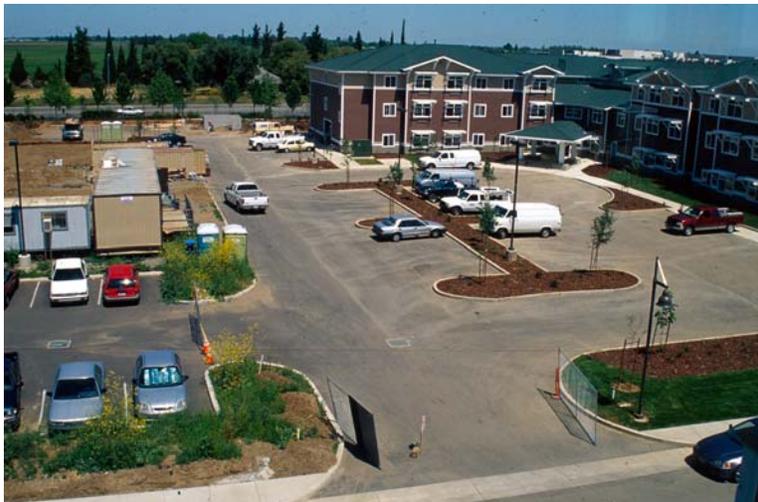
Fig. 1. Soil evaluations were conducted at 3 locations within 500 yards of one another. The developed site is in the foreground and samples were taken from the construction area on the left (not landscaped). The agricultural field is in the background: a green field beyond the trees at the top of the photo. The fallow field is between the developed site and agricultural field, to the right of the stand of mature trees.

A recent building project in Davis, CA, provided an opportunity to compare soil qualities at a developed site with two undeveloped sites (fig. 1). The developed site, a one-year-old residential retirement community, had significant problems with many plant materials due to unfavorable soil conditions. A preliminary assessment of soil conditions indicated limitations associated with soil pH, salt content, texture, and bulk density. In many locations, soils remained highly saturated or flooded for days after irrigation or rainfall (fig 2).

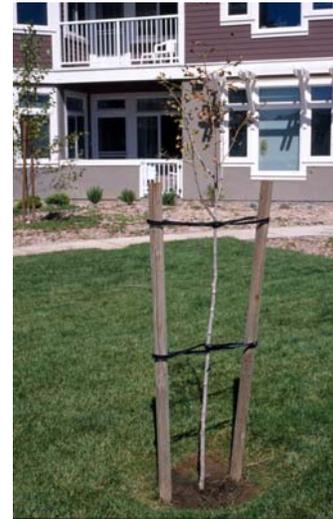
Fig. 2. Within a year after the landscape had been installed at the developed site, many trees declined. Here, a maidenhair tree (Ginkgo biloba) shows symptoms of an aeration deficit: chlorosis, leaf drop, and little or no growth. The aeration deficit was attributed to excess water in the root zone from irrigation and poor drainage.

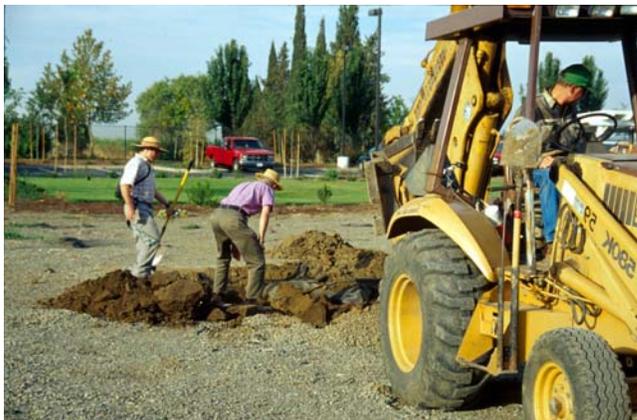
Fig. 3. Soil inspection and sampling pits were excavated in all three locations using a backhoe. Here, a pit is being dug at the developed site.

Soil inspection and sampling pits were excavated at each location using a backhoe (fig 3). Two trenches were excavated to form a T-shaped pit. Trenches were 6-feet deep and

approximately 2-feet wide and 6-feet long. Soil samples were collected on a smooth and uniform sidewall at the juncture of the two trenches.

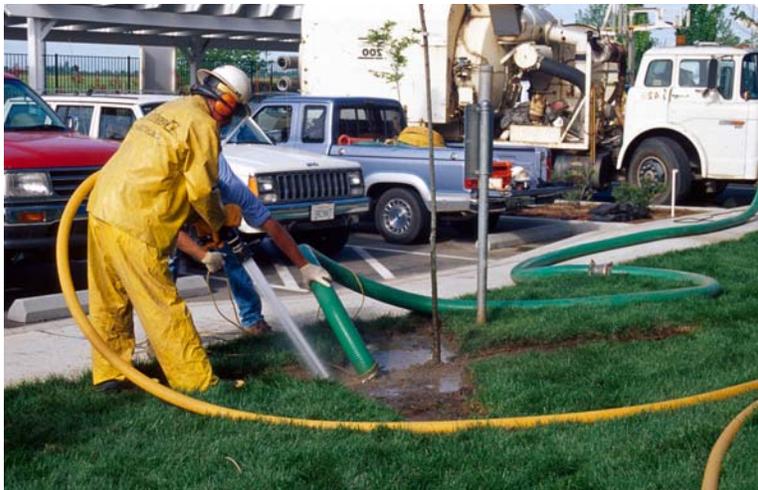
Fig. 4. To remediate soil conditions that limited tree development (principally compaction), soil around declining trees was removed using a hydroexcavation technique and replaced with a higher quality soil. Here, soil is being dislodged with water (under high pressure) and the slurry is being vacuumed.

removed and trenches created using a hydroexcavation technique (Gross 1993) where high-pressure water is used to remove soil, and the soil-water slurry is withdrawn into a holding tank using a vacuum unit (fig. 4). Two trenches configured in an X-shape at each

planting site were excavated, with each trench being approximately 10-feet long, 12-inches wide, and 16- to 26-inches deep. After water drained from the trenches, a soil with high sand content was installed, irrigated, and allowed to settle for several days (see table 1 for analysis of replacement soil). Replacement trees (*Zelkova serrata*, *Ginkgo biloba*, and *Acer rubrum*) were planted at each of 12 sites with replacement soil. In addition, trees were planted at 3 sites where a declining tree was removed but no soil remediation was performed. Since both tree and soil conditions at the site did not allow for complete replicates of treatments, however, this work was conducted for demonstration purposes only. Measurements of tree trunk diameter and canopy density (visual assessment) were taken at planting, and subsequent measurements will be taken annually.
