# Selection and Propagation of Deep-Rooted Ornamental Trees for Urban Environments

David W. Burger

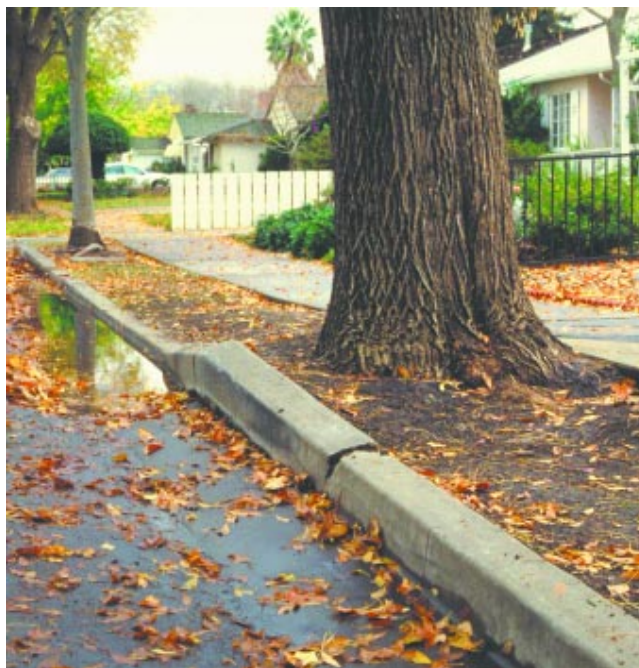
**Severe sidewalk and curb damage due to shallow tree roots and narrow planting strip. (Fig. 1)**

Some trees, however, have root systems that cause damage to sidewalks, curbs and gutters (Figure 1). This damage is the result of planting trees in planting areas that are too small or too narrow and/or the tree's inherent tendency to have shallow, horizontally developed roots. As these shallow roots produce secondary thickening growth, they tend to upheave pavements around them.

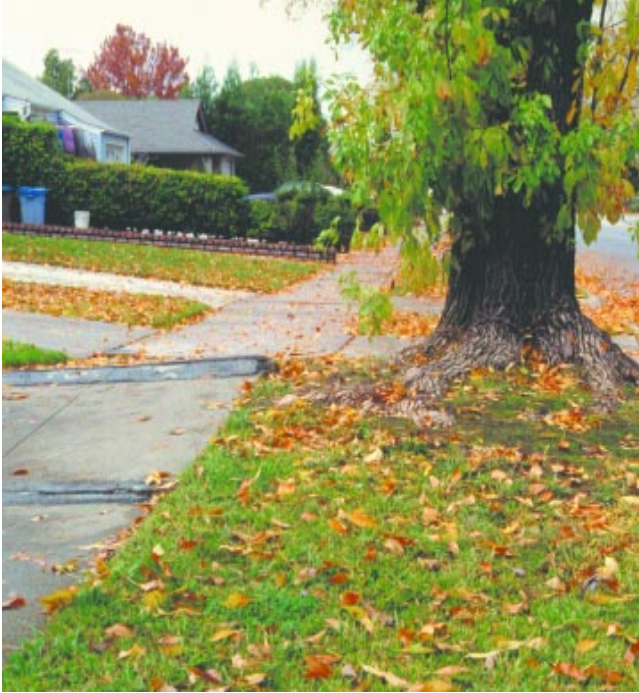
**Sidewalk upheaval adjacent to a wide planting strip, due to shallow tree roots. (Fig. 2)**

Suggested and/or attempted solutions to this problem are myriad (Hamilton, 1984b). Most of them focus on management practices of one sort or another and include: careful water applications, growing trees in wider planting strips (Figure 2), increasing soil aeration, root pruning, root barriers, copper screening placed in trenches, avoidance by redirecting sidewalk paths (Figure 3), deep planting, and tree removal.

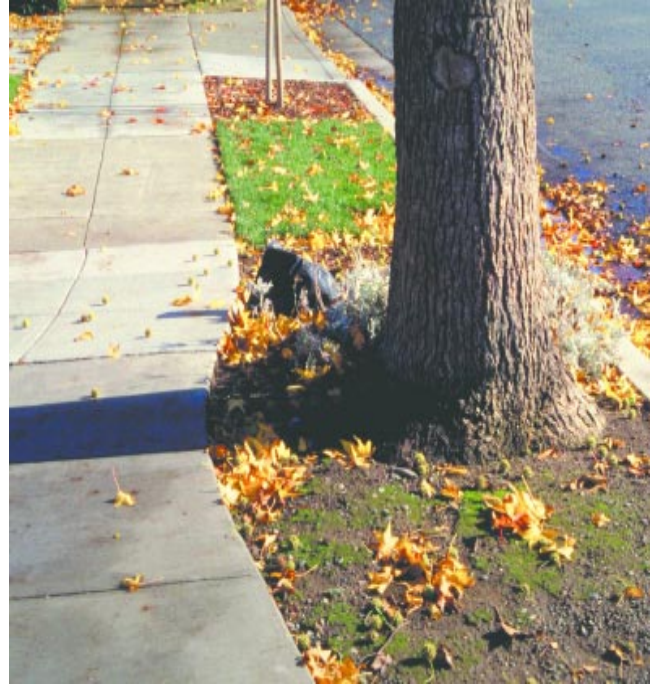
**Avoiding shallow tree root damage by redirecting the sidewalk path. (Fig. 3)**
